# Preliminary Measurements Supporting Reactor Vessel and Large Component Inspection Using X-Ray Backscatter Radiography by Selective Detection

Daniel Shedlock, Edward T. Dugan, Alan M. Jacobs and Laurent Houssay\*  
University of Florida,

**Abstract** – X-ray backscatter radiography by selective detection (RSD) is a field tested and innovative approach to non-destructive evaluation (NDE). RSD is an enhanced single-side x-ray Compton backscatter imaging (CBI) technique which selectively detects scatter components to improve image contrast and quality. Scatter component selection is accomplished through a set of specially designed detectors with fixed and movable collimators. Experimental results have shown that this NDE technique can be used to detect boric acid deposition on a metallic plate through steel foil reflective insulation commonly covering reactor pressure vessels. The current system is capable of detecting boric acid deposits with sub-millimeter resolution, through such insulating materials.

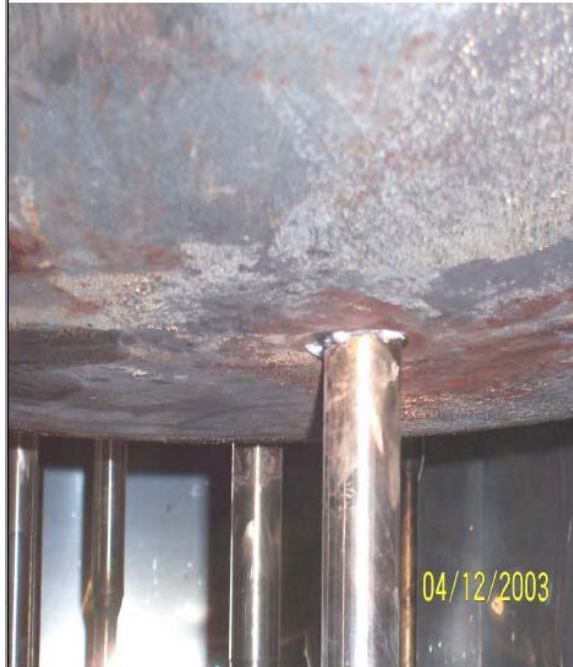
Figure 2 – STP BMI Penetration 1<sup>16</sup>

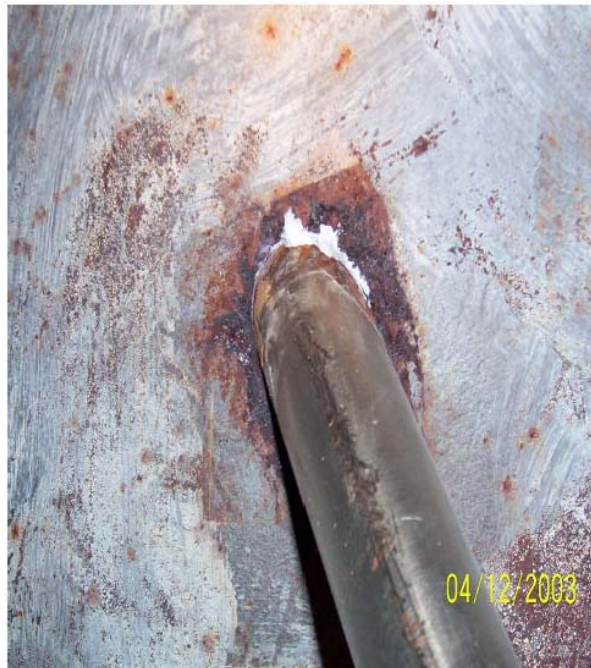
Figure 3 – STP BMI Penetration 46<sup>16</sup>

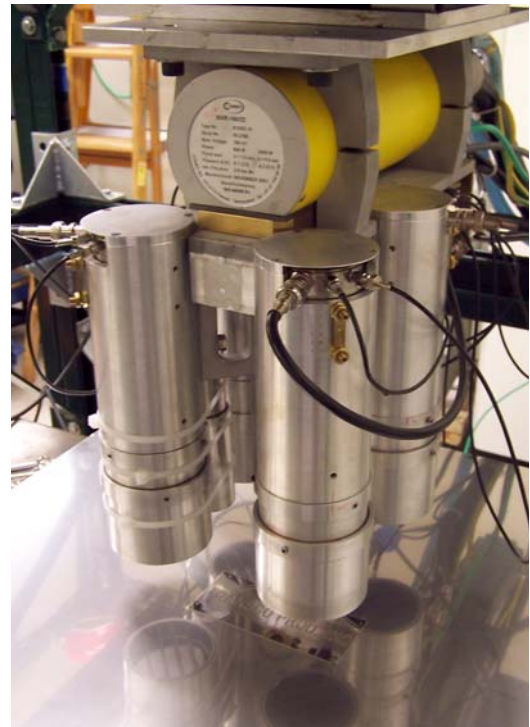
Figure 4 – Current RSD scanning system with TRANSCO mirror insulation

Inspection of these areas can be troublesome, especially if mirror insulation must be removed. Current RSD x-ray backscatter techniques can be used to inspect RPV penetrations without removing mirror insulation. Figure 4 shows an RSD x-ray backscatter device,

In general, as shown in Figure 4, the current RSD scanning system consists of the x-ray generator, an array of detectors, scanning table, and a computer to control data acquisition, motion control, and image generation. The array of detectors is fixed to the x-ray generator and designated as the scanning head. A highly collimated x-ray beam illuminates a single pixel, and a selective backscatter field is measured by the array of detectors. Movable collimators allow each of the detectors to view a unique field. The measured signal of less-collimated, or uncollimated detectors is dominated by single-collision events and contains surface and near surface information. The collimated detector signals can respond to single- and multiple-scatter photons. These photons have greater depth penetration and carry information about sub-surface features as shown in Figure 1. This feature makes it possible to image the RPV or any surface beneath the TRANSCO insulation, shown beneath the RSD scanning system in Figure 4.

The scanning system in Figure 4 was used to determine if it is feasible to find boric acid deposits and defects in steel structure through reactor pressure vessel insulation. The yellow cylinder is an Yxlon MXR-160/22 x-ray generator. This is a liquid-cooled x-ray generator with a maximum tube voltage of 160 kV. The scans used to detect boric acid through TRANSOCO insulation were performed at 100 kVp and 45 mA with a 5.5 mm electron beam focal spot. The four silver cylinders in Figure 4 are the detector assemblies. Each detector assembly includes a 50 mm diameter by 50 mm long NaI scintillator crystal, a photomultiplier tube and a specially-designed, high speed, ultra low-noise pre-amplifier from Inspirion LLC. The collimator assembly at the end of the detector includes an array of lead collimators and the design allows for independent adjustment of the assembly in different directions. This includes in-and-out movement of the outer, circular (sleeve) collimator; in-and-out and rotational movement of the inner collimator (collimator component with the lead fins); and in-and-out movement of the entire assembly. The collimator design provides the ability to “focus” the image by the selection of the desired scatter components. Each of the detectors generates a separate image and a cross-correlated image can also be generated from any combination of detector images. The x-ray illumination beam spot size used for these experiments was 1.5 mm for large deposits and 1 mm for finding very small deposits. The beam spot can be either round or square or customized for any application. The shape of the illumination beam is controlled by a lead insert (aperture) in the bottom of the brass, lead-lined source collimator tube that extends in a direction normal to the end of the x-ray tube and which is centered between the four detectors. The fastest linear scan rate for this system is about 50 mm per second. For 2 mm pixels, this translates into scanning rate of approximately 15 minutes per 0.093 m<sup>2</sup> (1 ft<sup>2</sup>). A LabVIEW-based program is used to control the scanner motion, data acquisition and image generation.

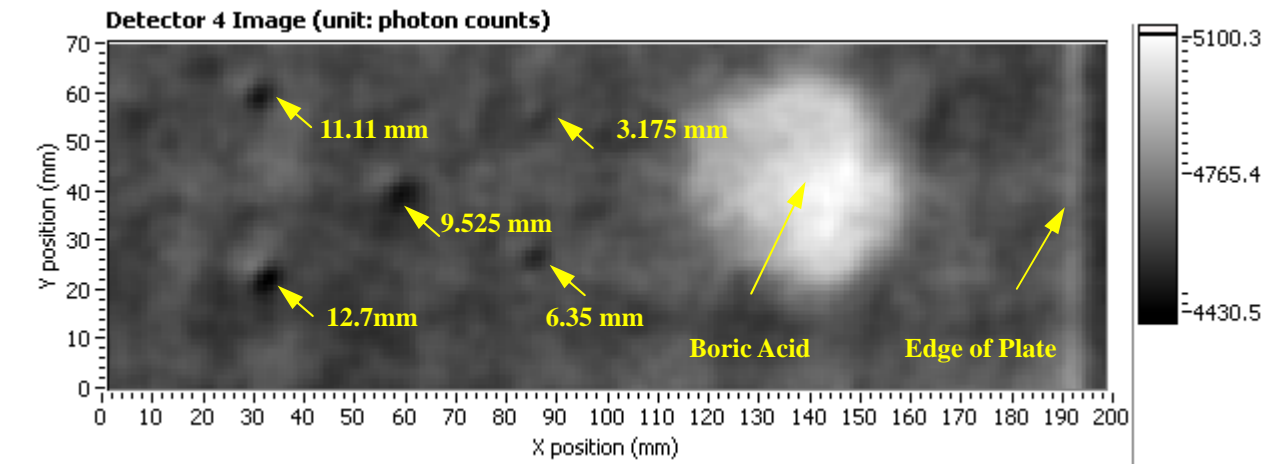
Figure 6 – RSD scan of steel plate with 5 holes and boric acid through TRANSCO insulation with a 7.62 cm air gap

This piece of steel plate was located 7.62 cm behind the TRANSOCO insulation and imaged using the RSD scanning system shown in Figure 4. The RSD x-ray backscatter image shown in Figure 6 was acquired at 100 kVp, 45 mA, and using 1.0 mm pixels. It took about 20 minutes to complete the scan. The steel plate is in the same orientation as shown in Figure 5 with 2 grams of boric acid deposit on the right side. Each of the five drilled holes is visible on the left of the image, and appears as a dark area of contrast. The boric acid residue appears as a large bright spot to the right of the drilled holes centered at position (x = 140, y = 45 mm). Boric acid is bright, because the absorption cross section for boric acid is lower than the absorption cross section of steel. To the right side of the boric acid residue is a vertical lighter contrast line at x = 192 mm. This is the edge of the steel plate.

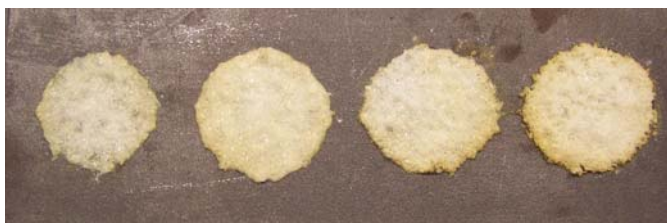
Figure 7 – From left to right, 51, 101, 153, and 204 mg/cm<sup>2</sup> of boric acid in 5 cm diameter circles

After easily locating the boric acid deposit and holes, a second set of experiments was performed to begin to determine detectable concentration levels of boric acid. One, two, three and four grams of boric acid were dissolved in water and spread over a 5 cm diameter circle on a piece of steel. This resulted in concentrations of boric acid with 51 mg/cm<sup>2</sup> (left), 101 mg/cm<sup>2</sup>, 153 mg/cm<sup>2</sup>, and 204 mg/cm<sup>2</sup> (right) as shown in Figure 7. Visually detectable concentrations are estimated to be between 50 and 100 mg/cm<sup>2</sup> based on the average size of crystals as boric residue solidifies.

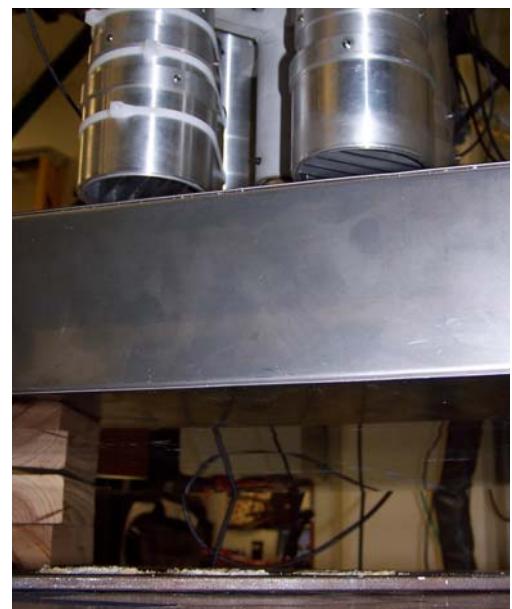
Figure 8 – Steel plate with boric acid deposits positioned 7.62 cm beneath 7.62 cm of TRANSCO insulation

The steel plate was then placed beneath the TRANSCO insulation with a 7.67 cm air gap as shown in Figure 8. Figure 9 is the RSD image which was acquired at 100 kVp, 45 mA, and using 1.0 mm pixels. All four boric acid deposits are easily visible. The top image is a correlation composite from all four detectors in the scanning system, while the bottom image is from

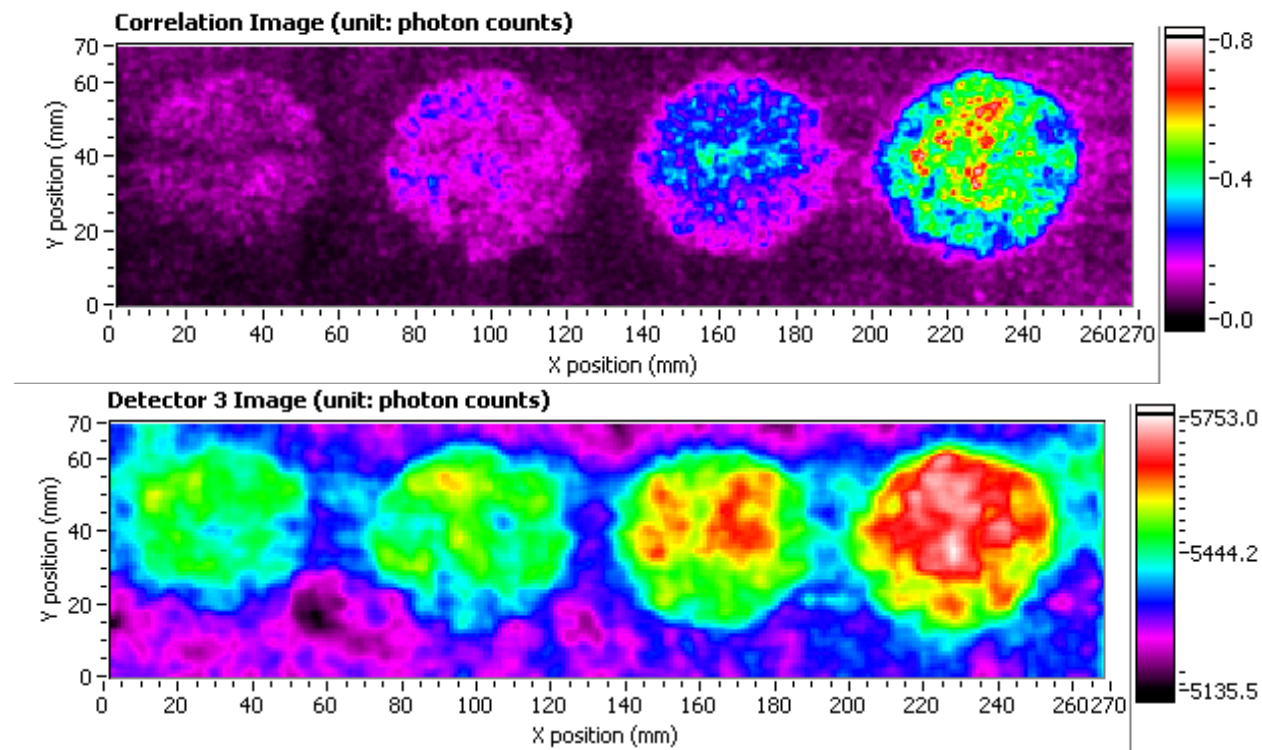
Figure 9 – RSD correlated (top) and detector 3 (bottom) images through TRANSCO insulation with deposits of boric acid in concentrations of 51, 101, 153, and 204 mg/cm<sup>2</sup> (from left to right) in 5 cm diameter circles

unprocessed data from detector 3. Current image processing allows for the images to be viewed in either color or grey scale. Image processing not only allows for cross correlation between image data from multiple detectors, but image filtering, and contrast adjustments. Raw data is also stored in ASCII text format for easy processing with software.

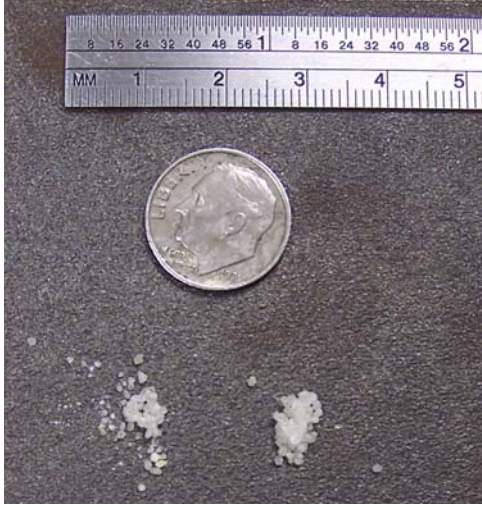
Figure 11 – 50 mg (left) and 100 mg (right) of boric acid residue on steel

Once it was determined that small concentrations (~50 mg/cm<sup>2</sup>) could be detected, it was time to test for very small amounts that may be present or seen during a visual inspection. Boric acid deposits are not typically in perfect geometric circles. Figure 11 shows 50 mg (left) and 100 mg (right) deposits of irregularly shaped boric acid on a steel plate. A United State dime is shown in the figure for perspective. The steel plate was placed behind the TRANSCO insulation with a 7.62 cm air gap between the insulation and the steel plate as shown in Figure 8, and scanned with an x-ray backscatter RSD system. Initially the boric acid deposits were difficult to detect. The illumination beam aperture was decreased in diameter from 1.5 mm to 1 mm and increased in thickness from 1.65 mm to 3.00 mm. The aperture changed increased the beam resolution and a scan was done at 100 kVp and 45 mA. This inspection took about 5 minutes and both the 50 mg and 100 mg boric acid deposits are clearly visible in the image, Figure 12. It is important to note that the boric acid deposits are still visible even with the dime taking a portion of the image contrast.

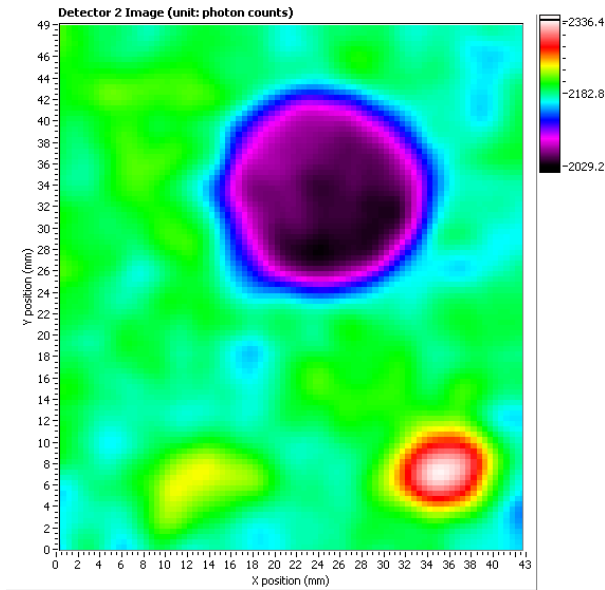
Figure 12 – RSD image of a dime (top), 50 mg (left), and 100 mg (right) of boric acid residue on steel through TRANSCO insulation
